Executive Summary

A/C Airflow Report

Alessi-Sromovski Residence

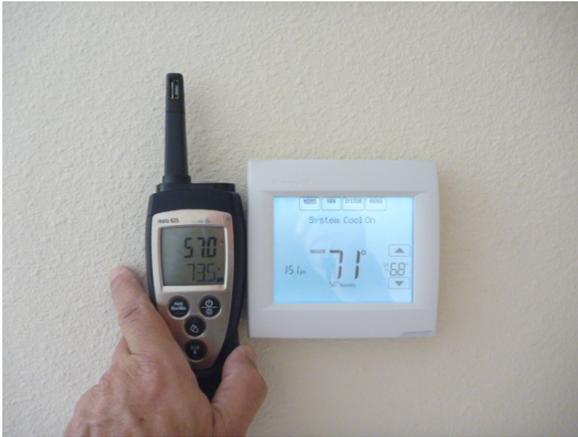
During our inspection of the home the relative humidity with the system running, was in the range of 50% through out the house. The maximum was 51.5% and the minimum was 49.5% . We also found that both thermostats understated the temperature by a little over 2 degrees. So when the thermostat displayed 71 degrees the temperature was a little over 73 degrees.

1 downstairs thermostat displaying 71 degrees actual temperature 73.5 degrees

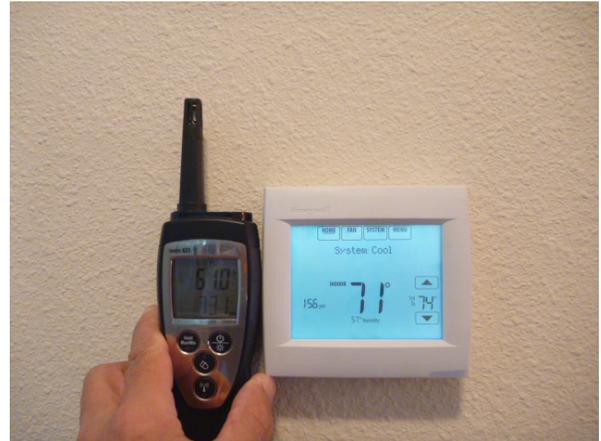
2 second floor thermostat displaying 71 degrees actual is 73.1 degrees

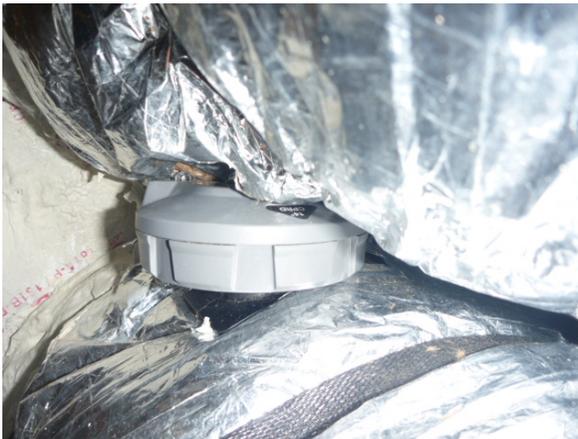
- 5 Bypass Damper: The bypass damper is not fully closing. That means that approximately 15% of the cold supply air is recycling back to the air handler without ever reaching the conditioned space. This is causing the return air temperature to get colder and colder and in turn make the supply air temp even colder. This should have set off the temperature sensor but we found that the sensor wire was not connected to the sensor dats contact on the zone board. If it was connected the condenser would shut even during cooling mode. This colder supply air satisfies the thermostat very quickly which reduces evaporator coil residence time and as a results reduces dehumidification.

- 15 Attic Inspection Bypass Damper: The bypass damper is hidden behind two trunks and gaining access to it is very difficult. The housing seems to be loose and it needs to be repaired so that it closes completely when required.

3 bypass damper is virtually impossible to get to. The housing is loose. It needs to be repaired

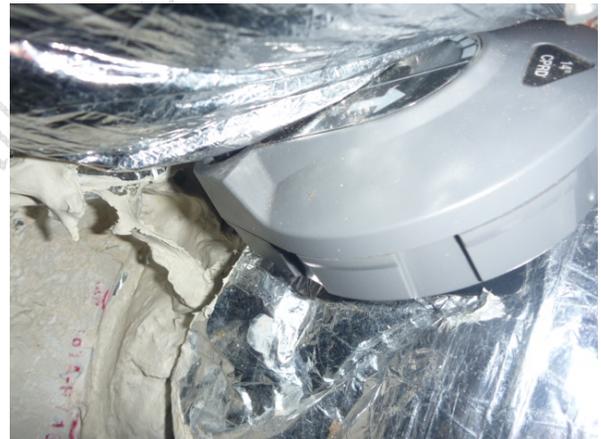
- 16 Attic Inspection Duct Work: The attic above the second floor is very cramped and as a result much of the duct work above the air handler is packed in very tightly. An effort should be made to try and separate the duct work as much as possible. There is no evidence of duct air leakage. However, there is evidence of duct insulation failure on the second floor attic. These should be repaired. Additionally, there is one trunk in the first floor attic within its insulation opened. This too should be repaired. (See repair procedure at the end of this report).

4 The attic space is very limited and there is a lot of duct work in this space making access difficult.

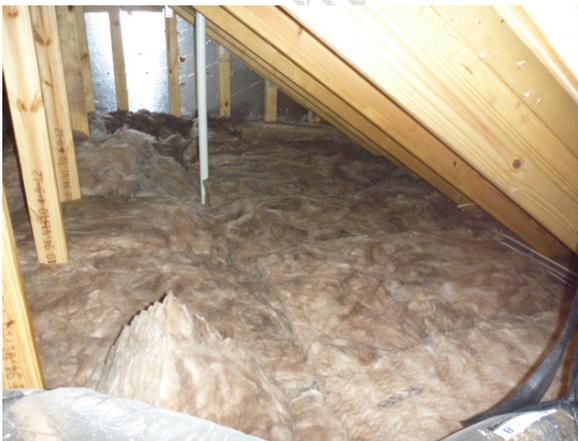
5 second floor attic batt insulation

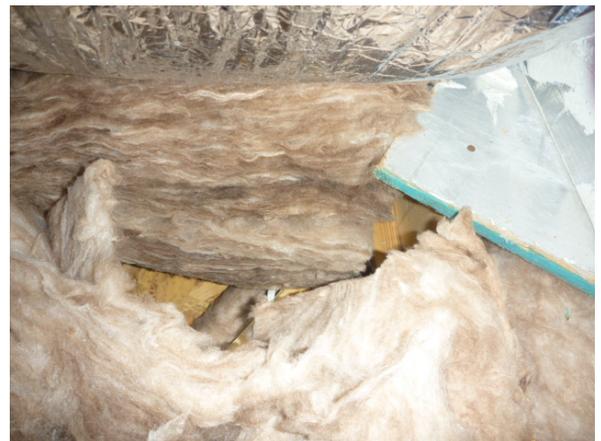
- 17 Attic Inspection Insulation: There are traffic areas in the first floor attic that should be resurfaced with blown fiberglass insulation. There is a gap in the batt insulation above bedroom 5. This should also be repaired. The second floor floor system or interstitial space is open to the first floor attic. This is permitting hot moist attic air to enter this space. The perimeter of the interstitial space should be sealed with an air barrier.

6 gaps in the second floor batt insulation

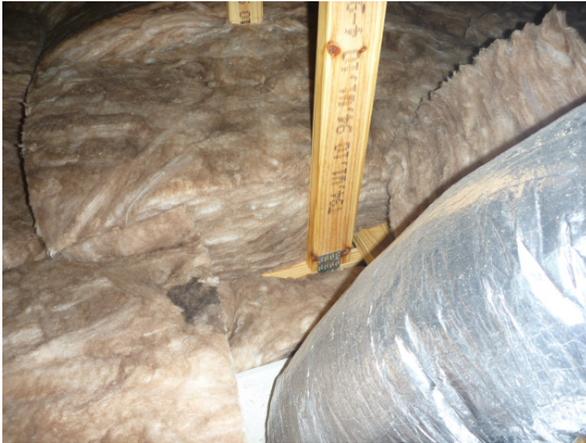
7 gaps in the second floor batt insulation

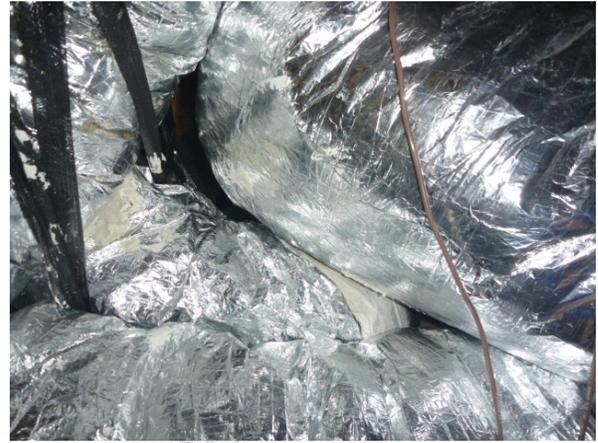
8 too little space for the duct work to pass

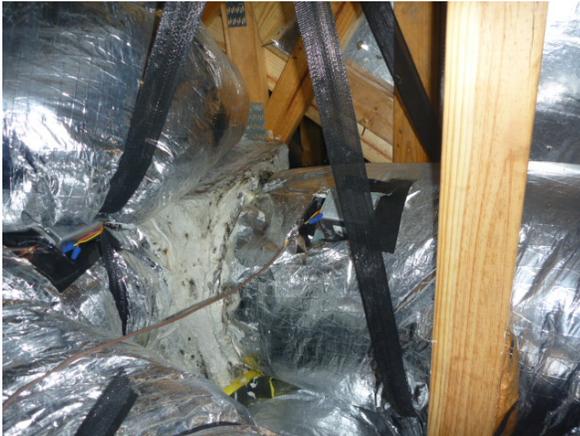
9 both zone dampers visible - signs of insulation failure and supply plenum

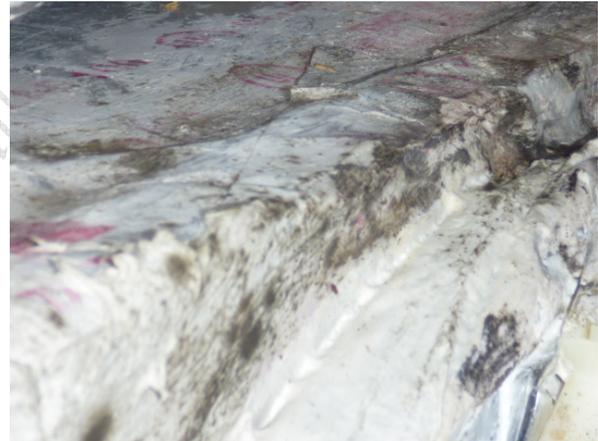
10 insulation failure along the edge of the supply plenum

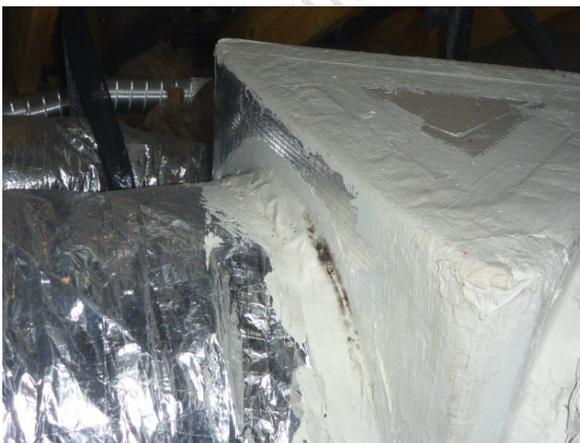
11 first floor attic - mixing box

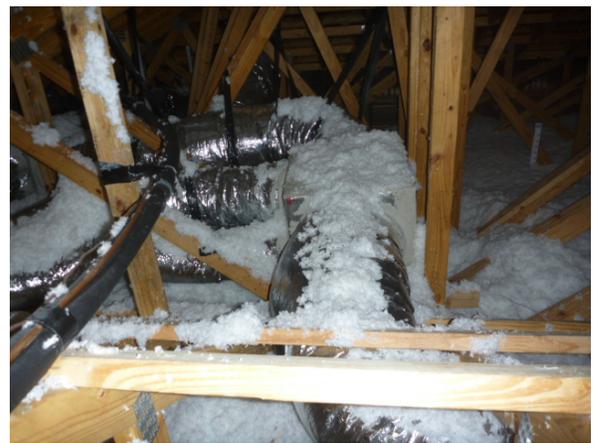
12 first floor attic - supply duct work

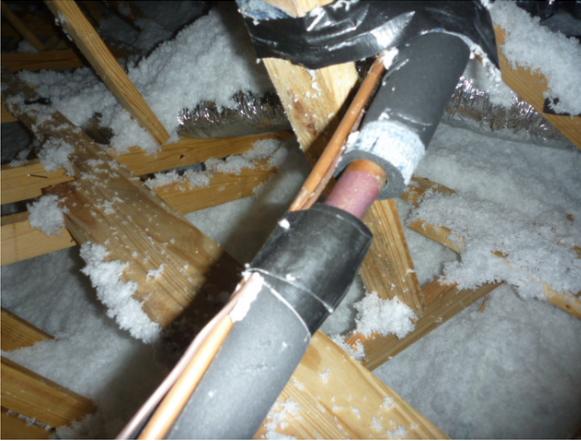
13 missing armor flex insulation - above the family room - this should be repaired

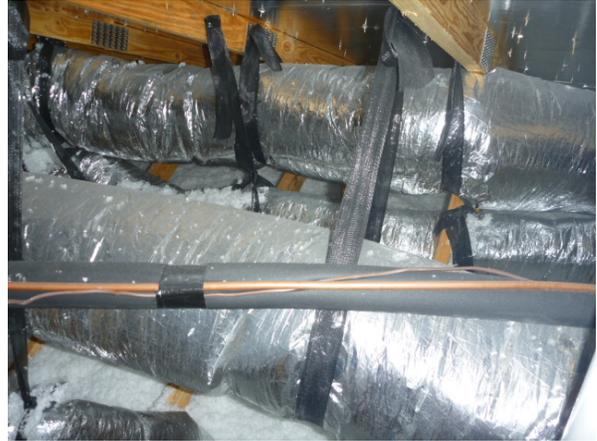
14 duct work properly supported

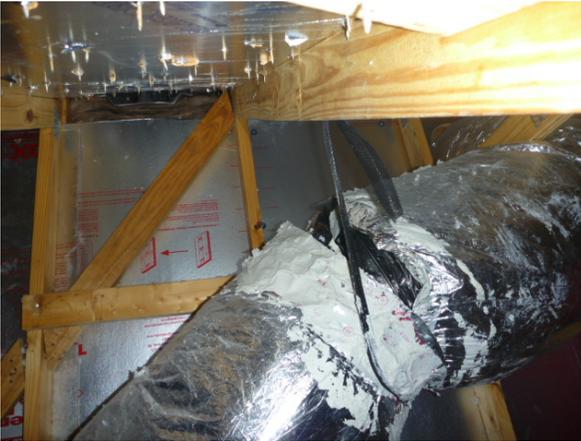
15 outer wrap has opened - this should be repaired

Flex Duct Connection Repair Procedure

The inner wrap should be completely removed and any wet duct board or insulation should be replaced. Also, the mating surfaces must be thoroughly dry before the repair can be performed. The mixing box collars and boot throats on the connections should be sealed and completely coated with a 1/8th inch layer of UL 181 approved mastic. The inner wrap should then be slid over the mastic covered mating surface, mechanically fastened and the outer surface of the inner wrap and the interface should be sealed and coated with another layer of UL 181 approved mastic. The outer wrap should then be pulled over the connection, snugged to the mating surface, mechanically fastened, taped to the mating surface and sealed with another layer of UL 181 approved mastic to the interface. The boots must be completely covered with a blanket of insulation and the mastic must be allowed to dry thoroughly before the system is restarted.

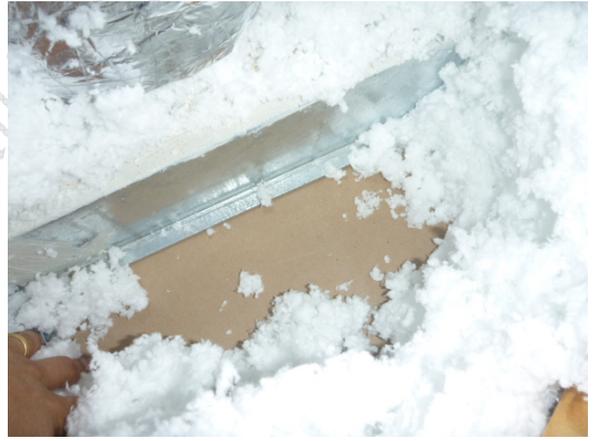
16 missing insulation

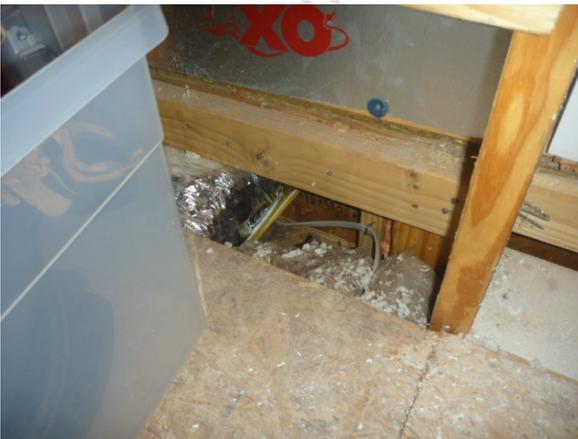
17 The floor system or "interstitial space" is open to the attic. Permitting hot moist attic air to enter.

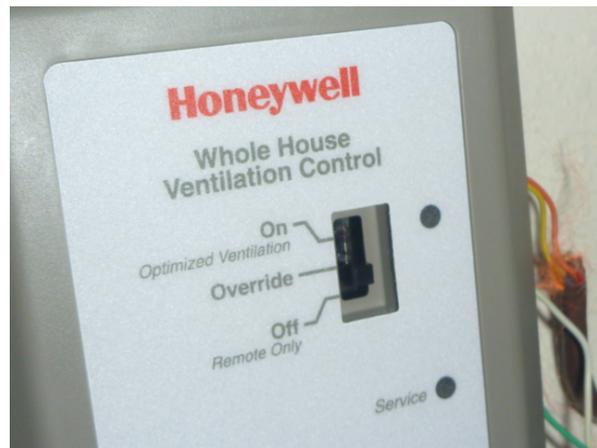
18 Honeywell 8150 ventilation control module

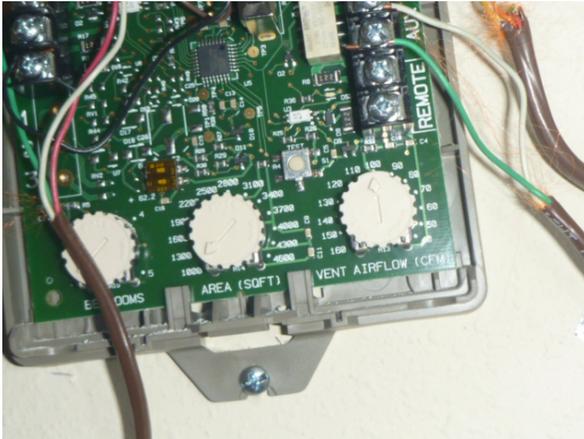
- 12 **Honeywell 8150 Ventilation Control:** The control module is set to 2 bedrooms, 1,000 sq. ft and 100 cfm. The master switch was in the off position. There is a red, green and white wire connecting the control module to the equipment side of the zone board. The green wire which is connected to the Gf terminal on the module connects to the G terminal on the equipment side of the zone board. It appears that this terminal is constantly energized because the air handler blower runs non stop. This should be disconnected as soon as possible and left that way until the cause is rectified.

19 Honeywell 8150 ventilation control module - settings
 2 bedrooms, 1,000 sq. ft., 100 cfm

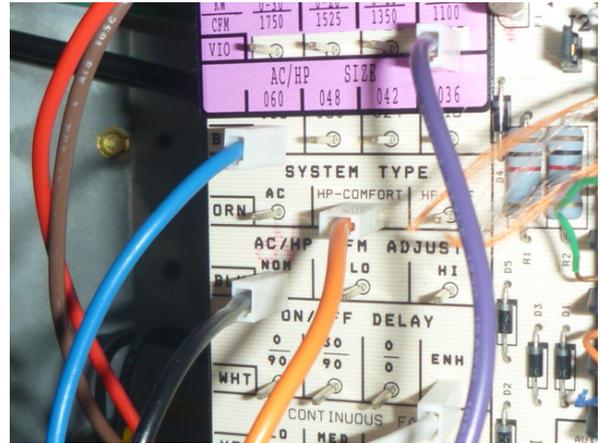
- 4 Air Flow Efficiency: This system consists of a 5.0 ton condenser and a variable speed air handler set to 5.0 tons and nominal speed. The air handler is set to deliver 350 cfm per ton for a total of 1,750 cfm. The supply is designed to deliver 1,750 cfm. It is actually delivering 1,485 cfm for an airflow efficiency of 84.9% Meanwhile the return is providing the air handler with 1,389 cfm of airflow vs a design of 1,750 cfm. The return airflow efficiency is 79.5%. The supply and return are both below the limits of acceptability of 90% to 105%. (see air flow primer for more information)

20 AHU set to 5 tons, nominal speed, hp comfort

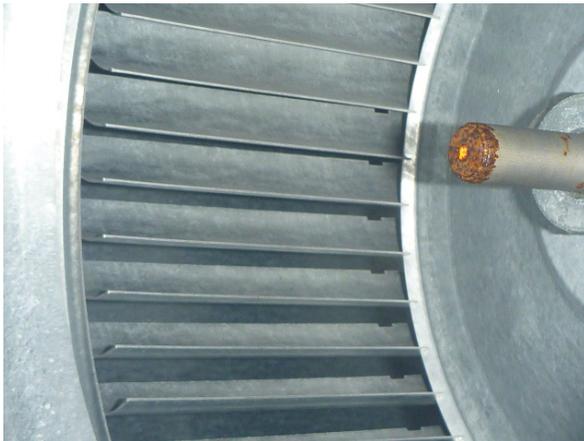
- 10 **Air Handler exterior:** The air handler is installed vertically inside of conditioned space. The exterior is clean.
- 11 **Air Handler Interior:** The air handler interior is clean.

21 air handler interior clean

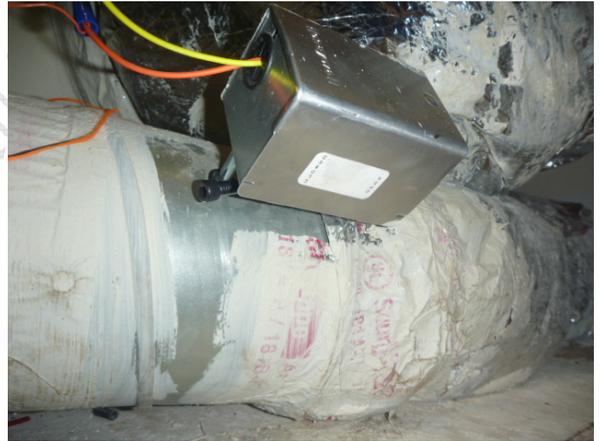
- 9 **Leakage:** The difference between the measured supply and the measured return is a return leak of 96 cfm or 5.4%. A portion of this is leakage around the outside air damper and the balance is within the duct connections. We could not confirm the ventilation air damper was closed. The return leaks are better than the 10.0% limits of acceptability.

22 ventilation damper - could not confirm it was closed

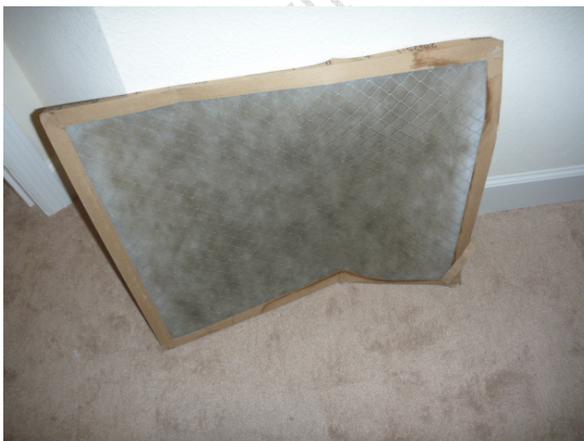
- 18 Whole House Filter Assembly: This system has a 1 inch filter installed. in air handler. The filter was very dirty. In fact it was so dirty that it had been pulled up into the air handler cabinet. Consider having the ac contractor install a 4, 5 or 8 inch whole house pleated filter assembly. This provides the excellent air filtration with very little effect on system airflow. Furthermore, these filters can last up to six months.

23 dirty filter - it was sucked up into the air handler cabinet

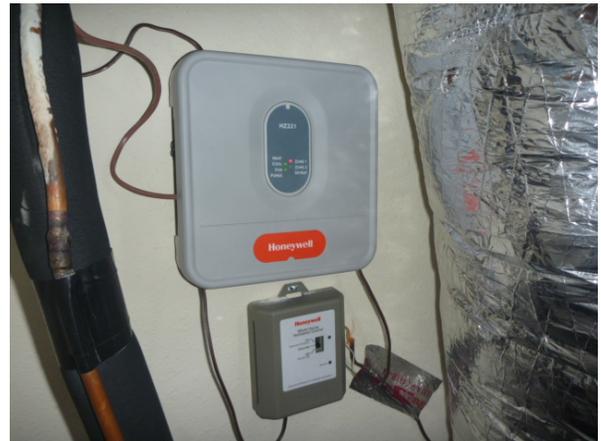
24 Honeywell zone damper and ventilation control module

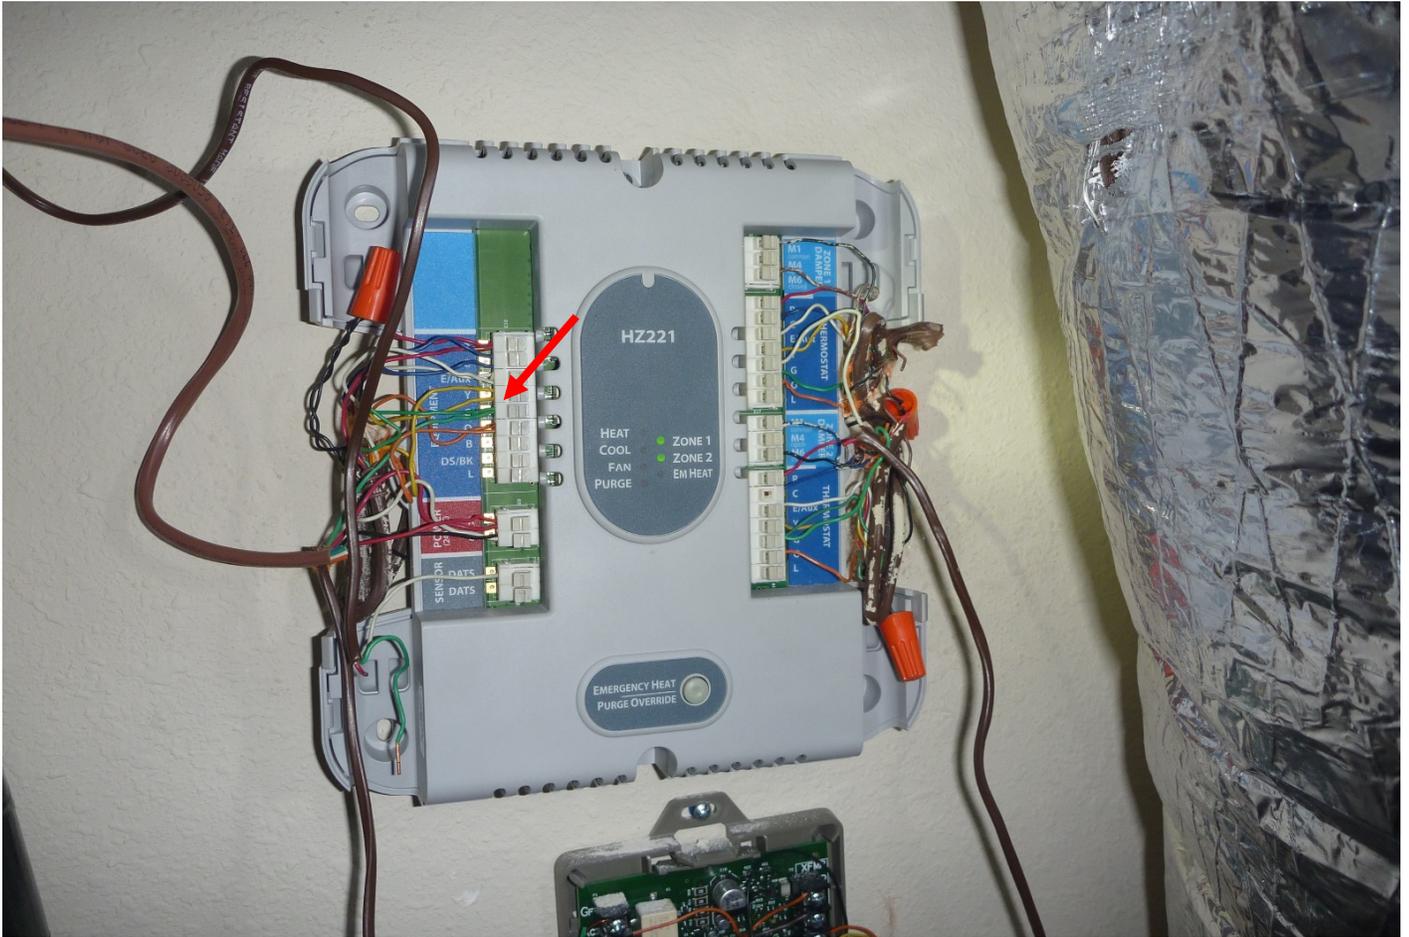
25 Honeywell HZ221 two zone board - arrow indicates the 8150 control wire that is constantly energized - this should be disconnected until the cause of the issue is rectified.

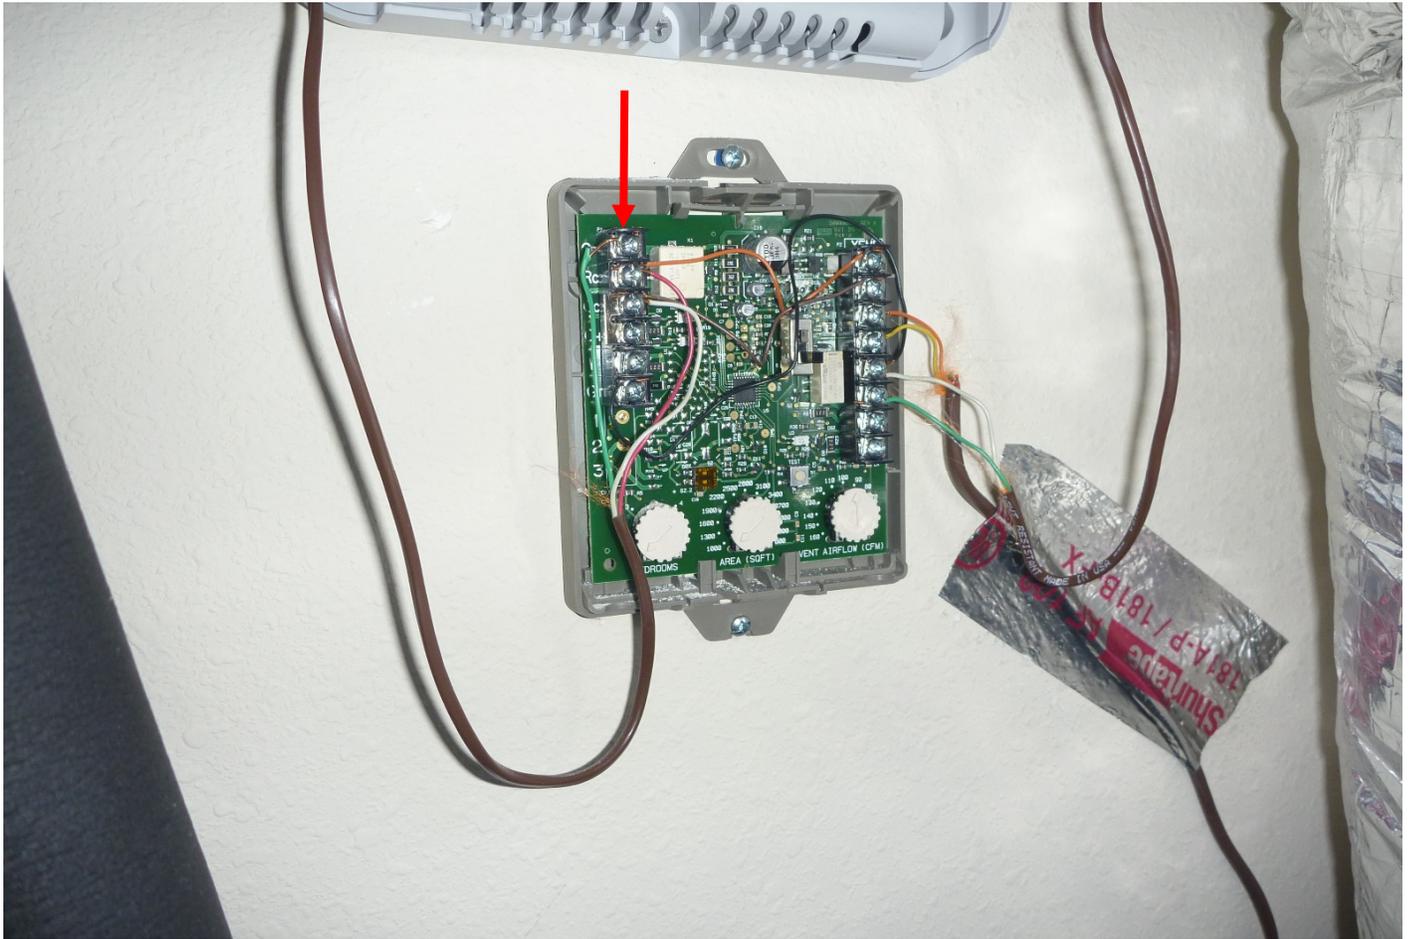
26 Honeywell 8150 ventilation control module - arrow indicated the source connection of the constantly energized contact - This module should be disconnected until the cause of the issue is rectified
