Executive Summary

A/C Airflow Report

Alessi-Sromovski Residence

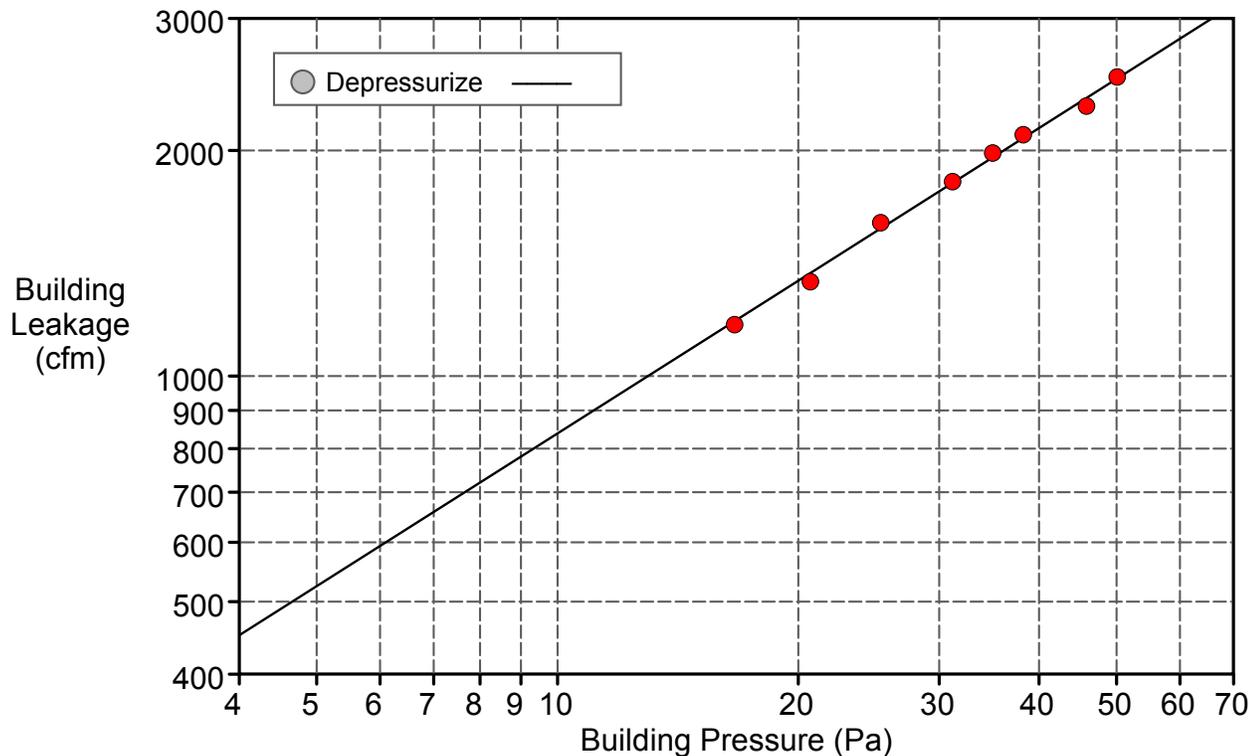
Leakage Areas: 246.3 in² (+/- 2.7 %) Canadian EqLA @ 10 Pa or 0.0867 in²/ft² Surface Area
128.0 in² (+/- 4.5 %) LBL ELA @ 4 Pa or 0.0451 in²/ft² Surface Area

Building Leakage Curve: Flow Coefficient (C) = 176.5 (+/- 7.3 %)
Exponent (n) = 0.677 (+/- 0.020)
Correlation Coefficient = 0.99731

Test Standard: CGSB
Test Mode: Depressurization
